Walker Property Evaluation Services

INSPECTION OVERVIEW

Client: Ken & Barbie Doll
Inspection Address: 1234 Beach Avenue, Malibu, CA 94000
Inspection Date: 12/31/2008 Start: 1:00 pm End: 4:30 pm
Inspected by: Skip Walker

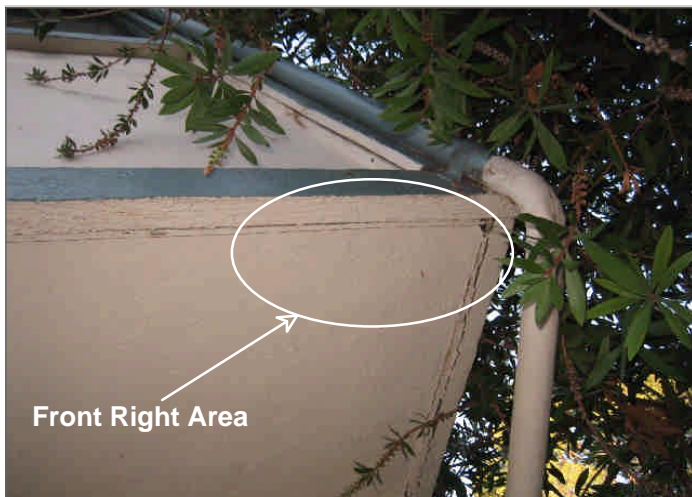
- q We noted staining and or other indications of moisture at the base of one or more cantilevered areas. This condition may be noted in the WDO report as well. We recommend that a qualified general contractor evaluate and service as necessary. These areas should be made fully accessible when repairs are undertaken. While we make every effort to identify potential problem areas during this limited visual inspection, the nature and full extent of damage may not be completely understood until the area is made fully accessible. It is possible that damage may exist elsewhere that is not visibly manifested in any way as well. The scope of this inspection is strictly limited to the readily visible portions of the dwelling.

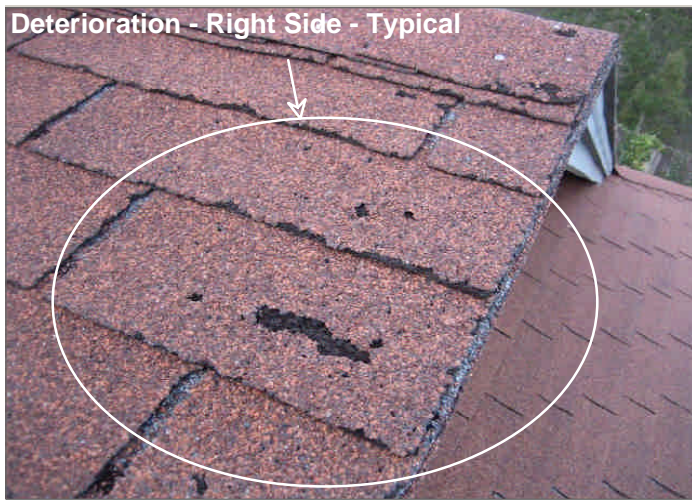
We noted several areas with age related wear deterioration and or other conditions needing service - *Continued*

- q We noted several areas with age related wear, damaged shingles, exposed fasteners and or other conditions that should be serviced. We found no visible indications of moisture intrusion in the dwelling and or attic areas at the time of inspection. However, our inspection is not intended to be a roof guarantee or certification. We recommend that the roof be evaluated by a qualified roofing contractor who will make appropriate recommendations as to required service or replacement.

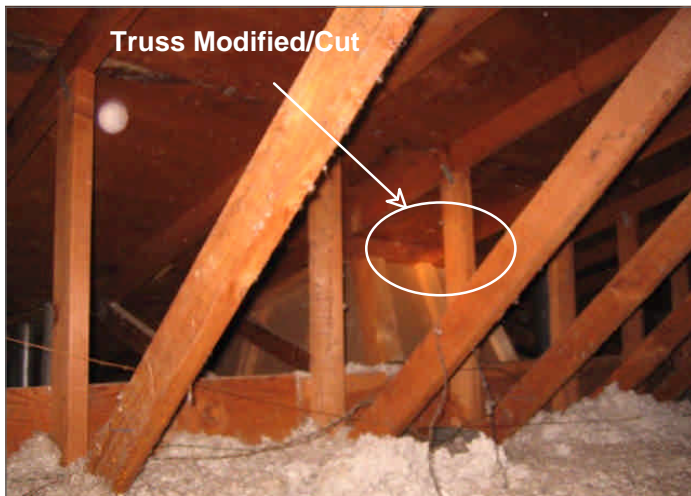
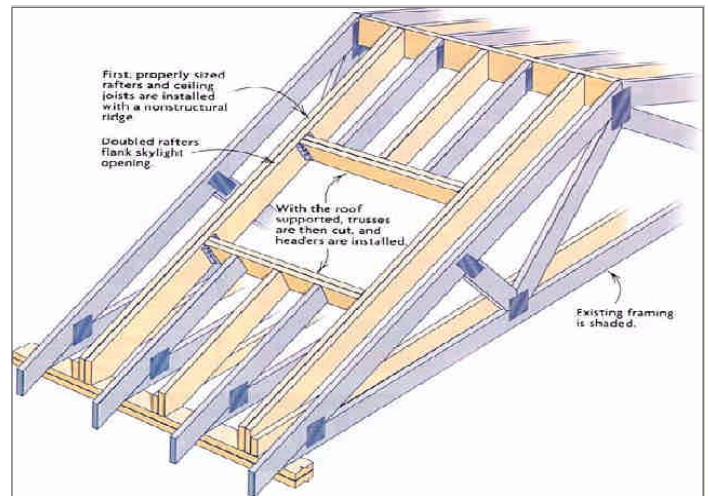
- We noted damage to one or more of the truss components in the attic that should be properly repaired. Damage, modifications or alterations to an engineered truss may alter the load capacity of the unit and make its performance under stress unpredictable. Repairs made to a truss component or system should be performed by a qualified general contractor according to the recommendations of a design professional.**

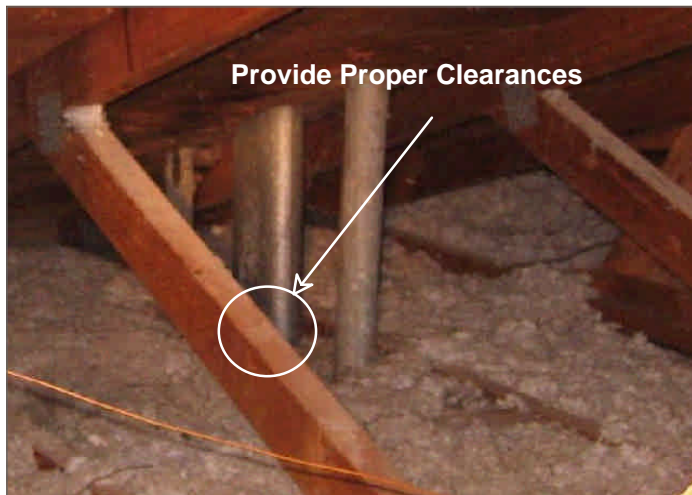
- q Insulation appears to be in contact with one or more double wall gas vent pipes. The insulation should be relocated/removed to provide the required clearances for fire-safety reasons. Interested parties should refer to listing requirements for the vent material for the required clearances. We recommend that a qualified trades person modify the installation to provide the necessary clearances to insure the safe operation of the system.

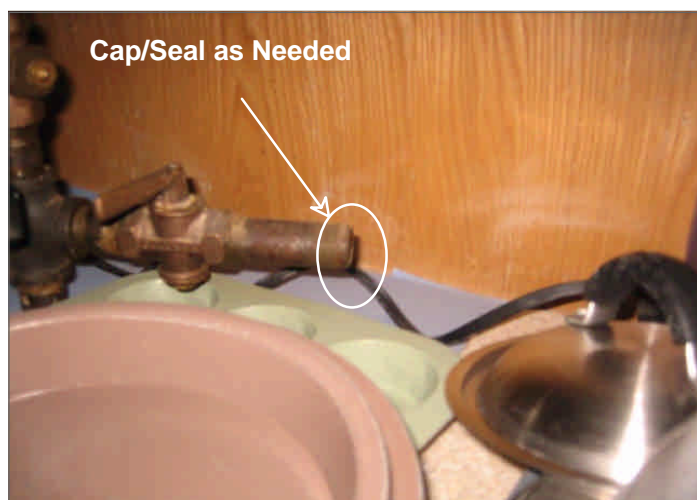
- q The gas service for the for the oven is not in use and is NOT capped as required. This is extremely unsafe and contrary to generally accepted gas safety standards. We recommend that a qualified plumbing contractor properly cap the connection for safety reasons.

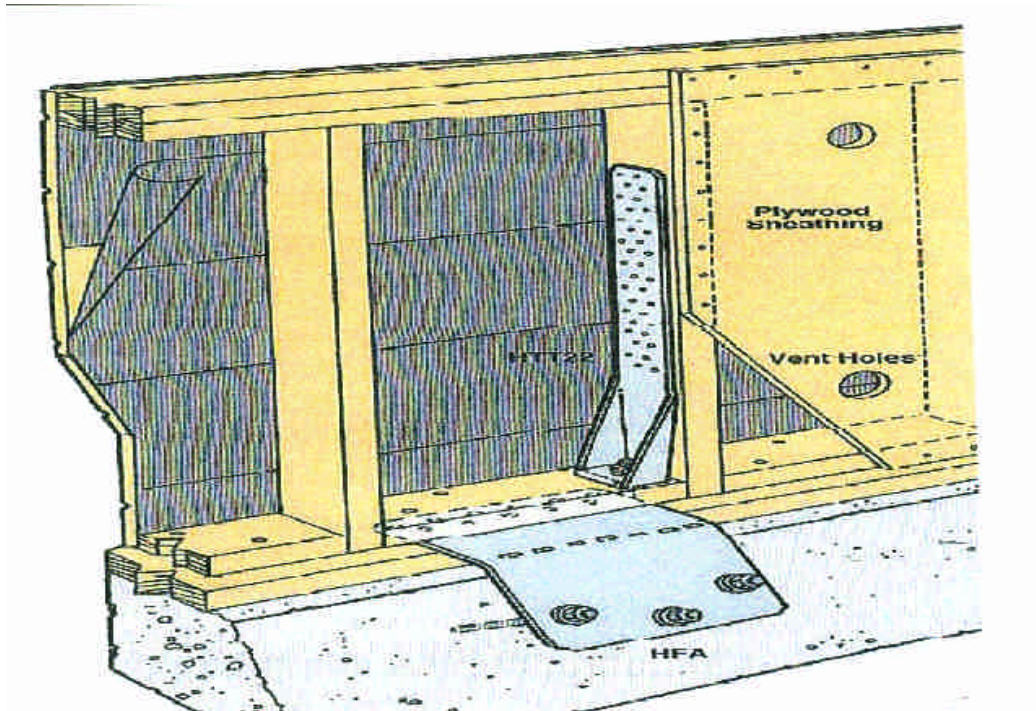
Illustration - 1 Hillside - Raised & Bolted - Unsheared Cripple Walls

- The residence is located on a hillside and has a raised and bolted foundation, with unsheared cripple walls. The cripple walls would be considered the portions of the wall structure and framing from the top of the perimeter foundation walls to the base of the first habitable floor. While not installing interior wood panels on the cripple walls was an acceptable construction practice at one time, we now know that this may make the dwelling more vulnerable in a seismic event. Shear panels are typically plywood or OSB panels nailed to the inside portions of the cripple walls to provide additional strength and stiffness to the walls. Interested parties are encouraged to have this condition further evaluated by a qualified seismic retrofit contractor who may make various recommendations to improve the seismic performance of the dwelling.

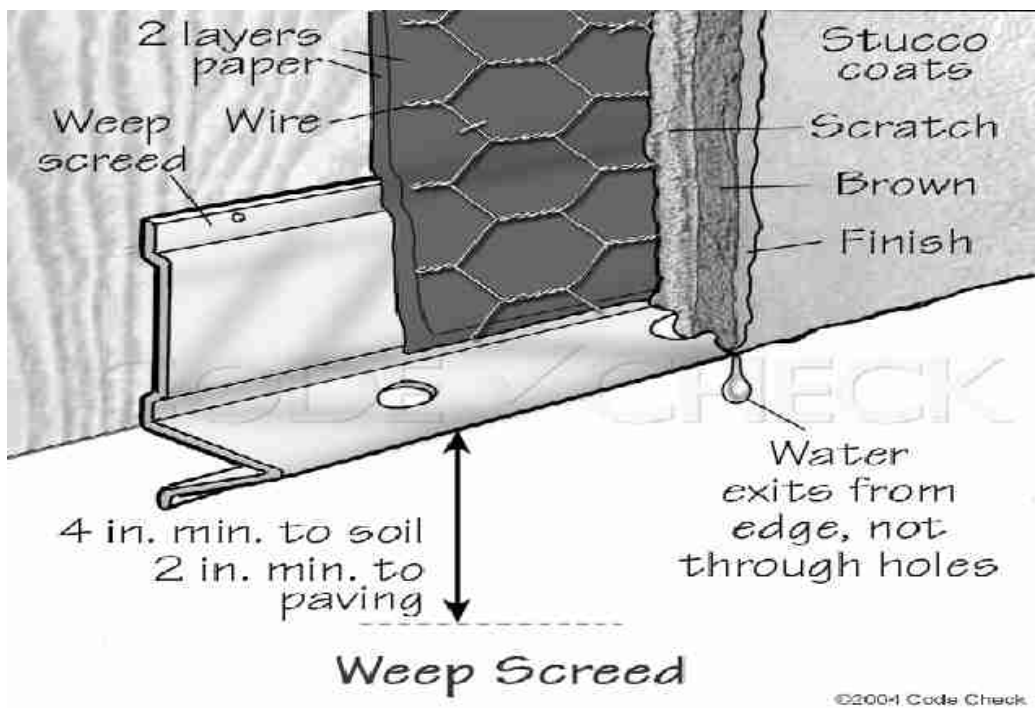
Illustration - 4 Portions - Stucco No Weep-Screed

- See Attached Illustration 3
- Portions of the stucco extend down to the soil without the benefit of a weep-screed, which allows the house walls to move independent of the foundation, and not only prevent the plate-line cracks that are commonly seen at the base of many stuccoed walls but isolates the stucco from the soil and inhibits the wicking effect of moisture being drawn up into the stucco that, in turn, creates the flaking and peeling that is common on such surfaces.

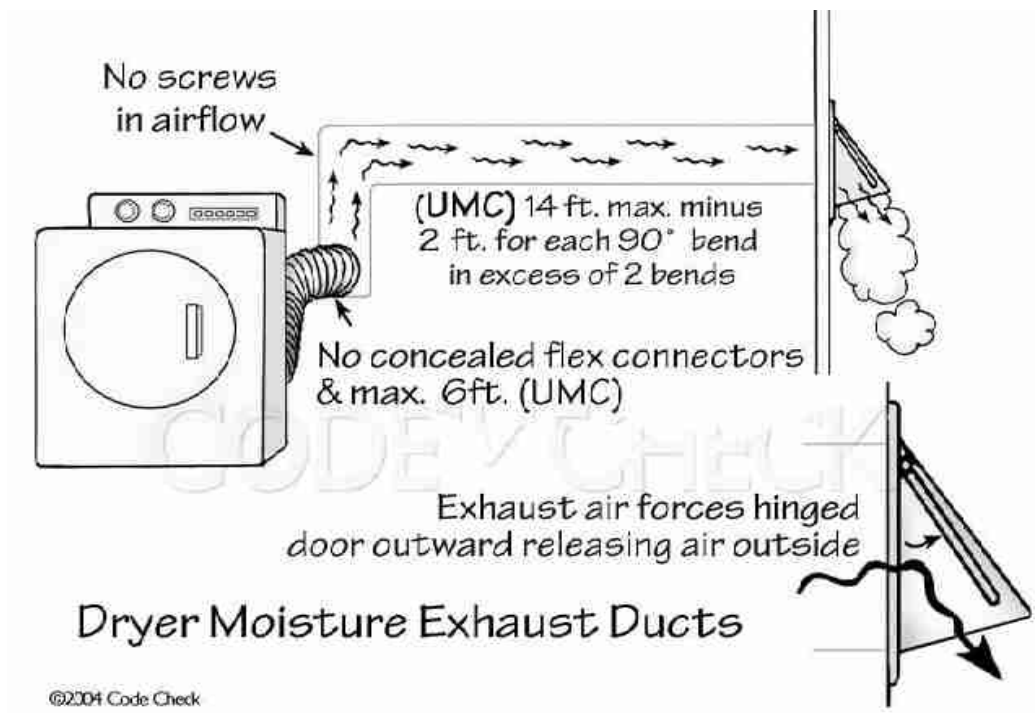
Illustration - 7 The dryer vent extends more than six feet in length and should be installed using a rigid metal vent material
