Walker Property Evaluation Services

INSPECTION OVERVIEW

Inspection Address: 1234 Beach Avenue Unit D, Malibu, CA 94000

Inspection Date: 12/27/2008 Start: 1:00 pm End: 4:30 pm

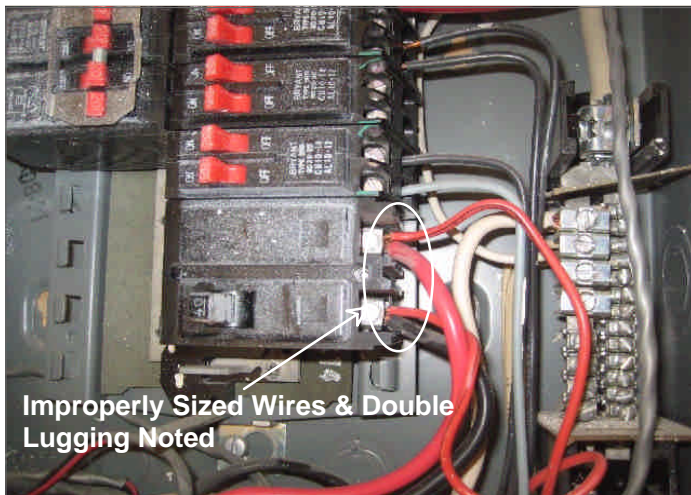
- q A 40 Amp 220 VAC circuit breaker appears to be serving undersized wires. This may allow the wire insulation to overheat/become damaged in an overload or short-circuit condition and poses a potential fire safety-hazard. We recommend that this installation be further evaluated and serviced as necessary by a qualified electrical contractor.
- q A 40 Amp 220 VAC circuit breaker is improperly serving multiple circuits. This practice is referred to as double-lugging or double tapping and is improper unless the breaker is specifically designed for this situation. Double lugging may result in improper electrical connections which can overheat the connection/circuit breaker. We recommend that the installation be evaluated and serviced as necessary by qualified electrical contractor.

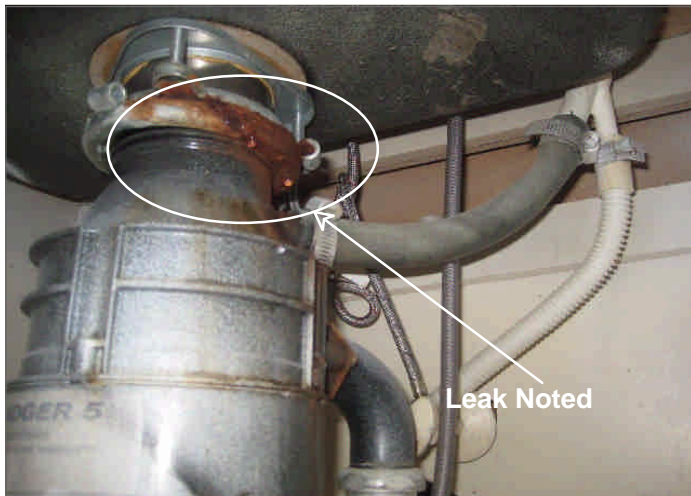
- q There is a leak where the garbage disposal attaches to the kitchen sink. We recommend that a qualified plumbing contractor evaluate and service as needed.

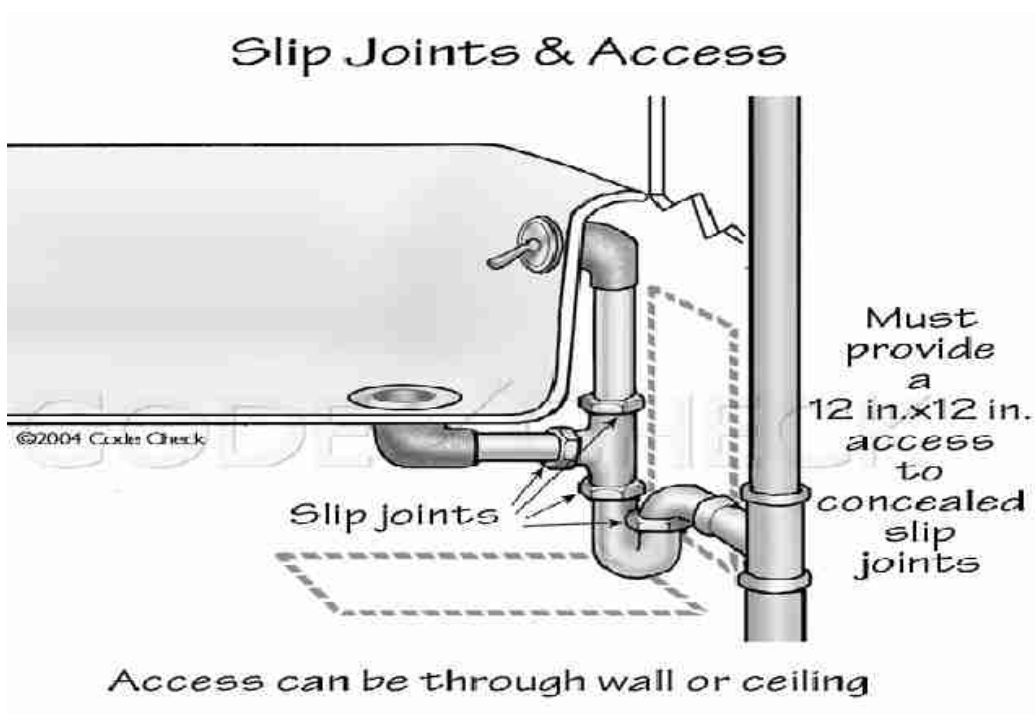
Illustration - 1 Tub-Shower Traps Not Accessible

- As noted elsewhere, one or more fixture drains are slow/blocked, and should be serviced by a qualified plumbing contractor.
- We noted one or more tub/shower/hydro-spa trap assembly's that do not appear fully accessible/visible and consequently could not be fully evaluated. Generally accepted plumbing practices require that any slip-joints on drain connections be accessible for service/replacement. It is suggested that any such installations be brought into conformance with applicable current standards. Interested parties desiring further information should consult with a qualified plumbing contractor.
- See Attached Illustration 1
- As noted elsewhere, we noted one or more sinks that appear to leak at the drain or trap below the sink. We recommend that all such areas be evaluated and serviced as needed by a qualified plumbing contractor.

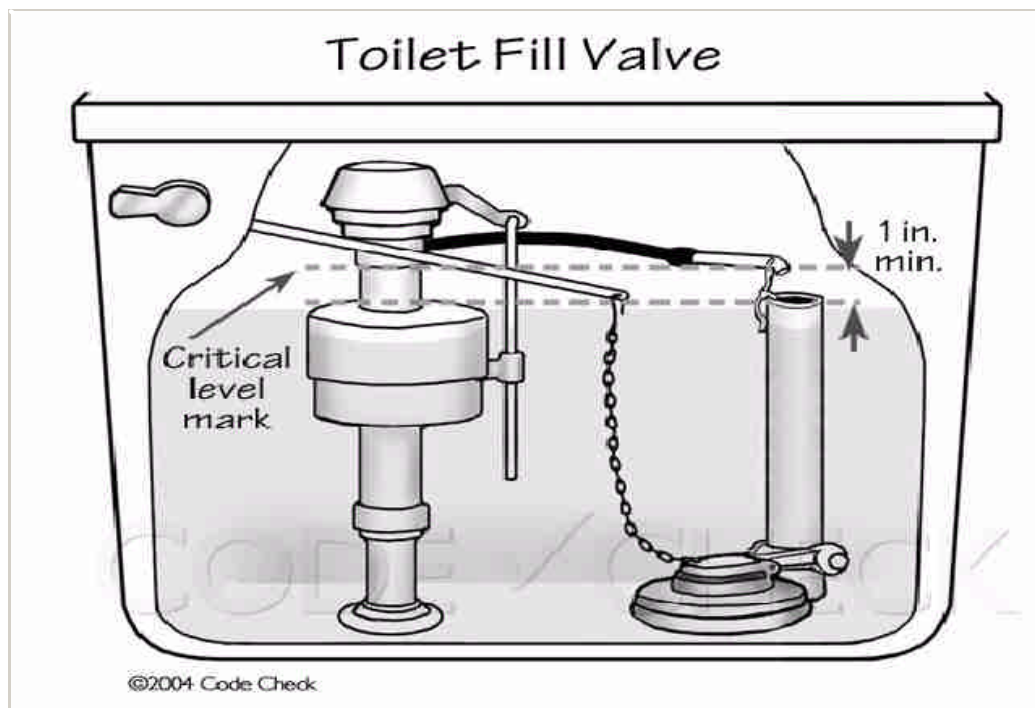
Illustration - 2 Toilet Fill Valve

- Q There is a potential waste to potable water cross connection at one or more toilets. The water supply at the flush valve should be installed to allow a minimum one inch air-gap at the fill tube. Air-gaps are required to prevent any possible contamination of the drinking water system should a sewer back-up/blockage occur at the toilet tank area. We recommend that a qualified plumbing contractor further evaluate and adjust or service as needed to insure conformance with current standards.
- See Attached Illustration 2

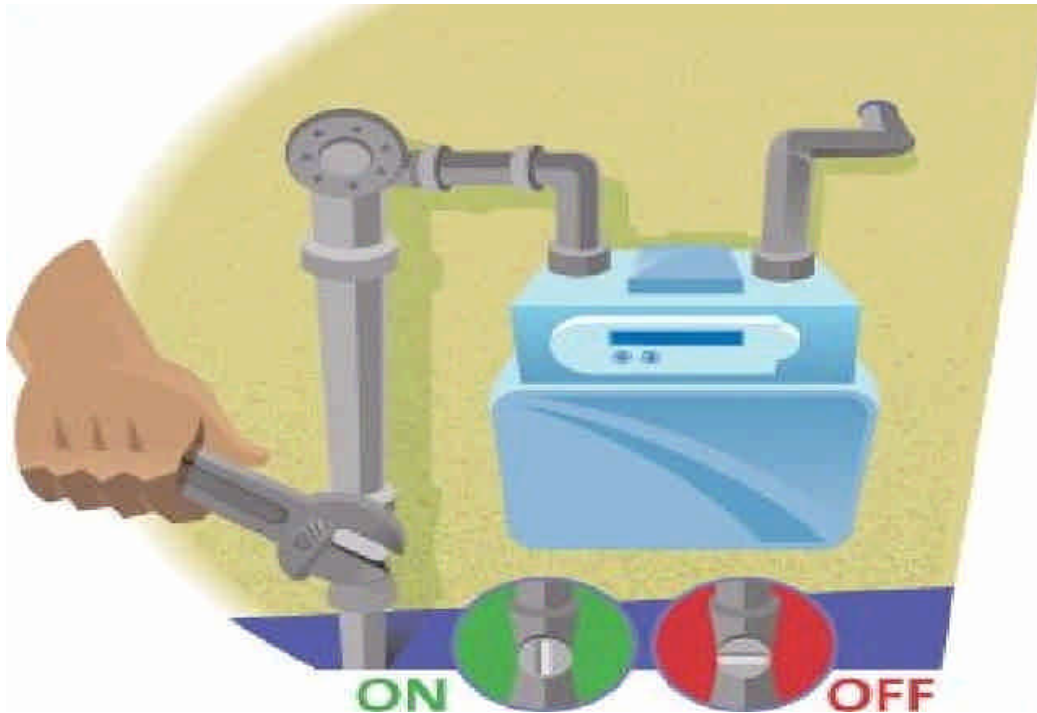
Illustration - 3 Homeowner - Emergency Shut-Off Procedure

- q We suggest that the occupants/homeowner become familiar with how to shutoff the gas in case of emergency. You should be aware that gas leaks are not uncommon, particularly after an earthquake or seismic event. Therefore, we recommend that you keep an emergency gas shutoff wrench in an accessible area and become familiar with how to shutoff gas should an emergency arise. Specialized equipment is necessary to detect a gas leak. Only the local gas utility or a trained professional should turn service back on after an emergency.

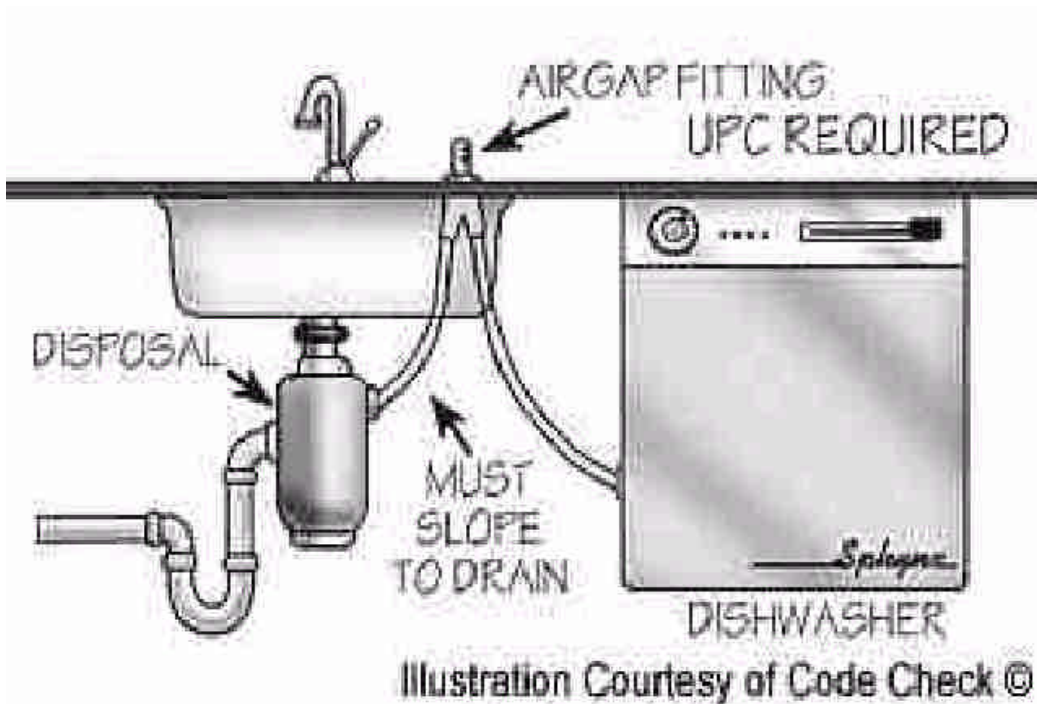
- q The dishwasher does not appear equipped with the required countertop air-gap assembly
- q The dishwasher did not progress through its cycle when tested and should be serviced or replaced

Illustration - 4 The dishwasher does not appear equipped with the required countertop air-gap assembly
