Walker Property Evaluation Services

INSPECTION OVERVIEW

Client: Ken & Barbie Doll
Inspection Address: 1234 Beach Avenue, Malibu, CA 94000
Inspection Date: 12/31/2008 Start: 1:00 pm End: 4:30 pm
Inspected by: Skip Walker

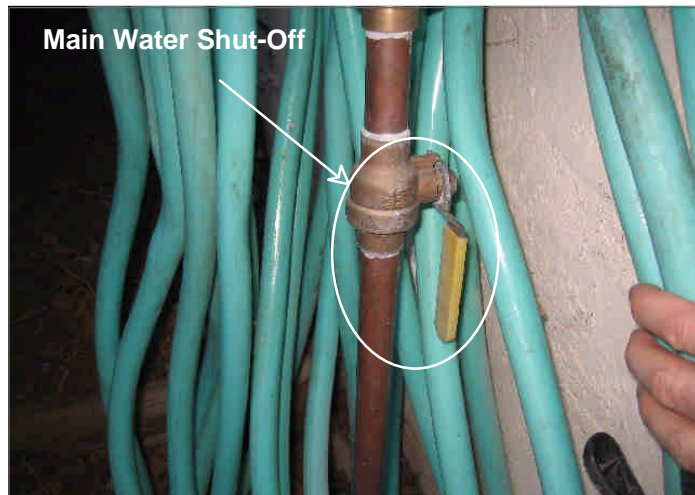
- The main water shut-off valve appears located at the front center of the dwelling by the garage.

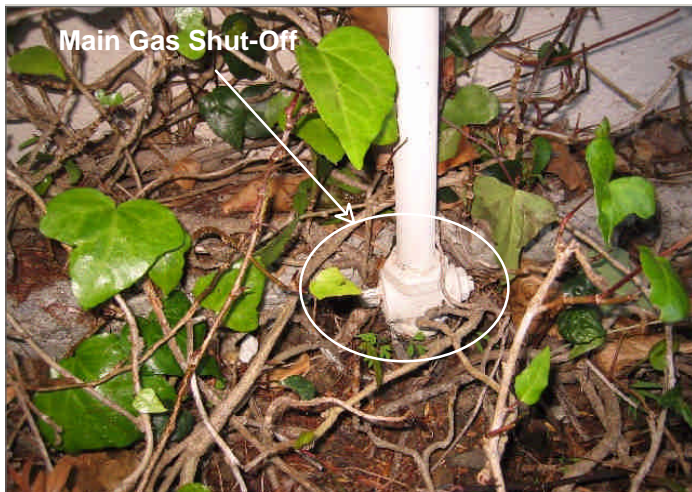
- The gas main shut-off is located at the right front side yard.

- q We suggest that the occupants/homeowner become familiar with how to shutoff the gas in case of emergency. You should be aware that gas leaks are not uncommon, particularly after an earthquake or seismic event. Therefore, we recommend that you keep an emergency gas shutoff wrench in an accessible

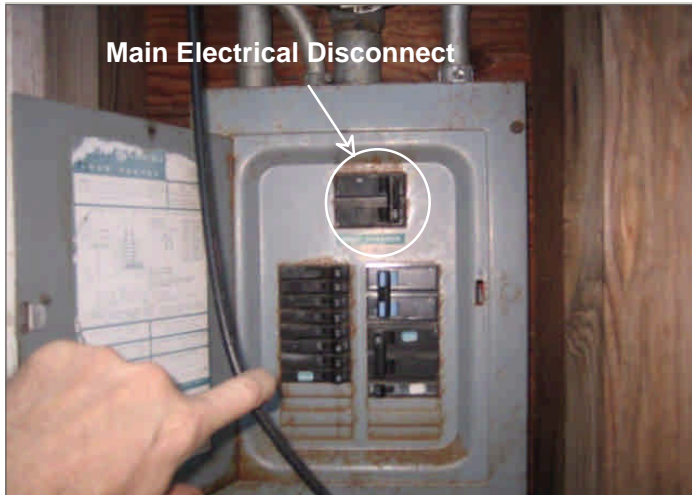
Main - Front RSY - Continued

- The residence is served by a 100 amp, 240 volt panel, located in the front right side yard.
